## IMPORTED THREADED ROD REPORT

In recent years, there has been an increase in low-quality threaded rods imported into the South African market. In an effort to highlight the dangers of poor quality imported rods, T&I Chalmers Engineering sent samples of M8, M10, and M16 mild steel threaded rods to IMP Labs and National Thread Grinding for independent analysis – The original reports are attached.

## Report 24-0956.

### Two Samples of Threaded Rod.

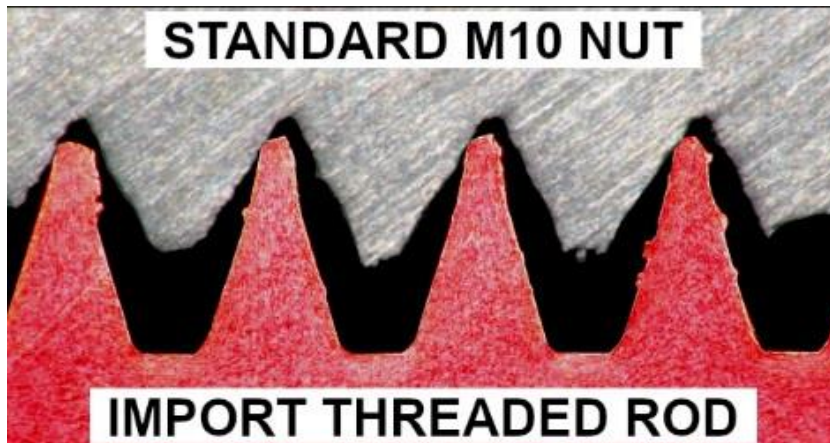
#### Import Threaded Rod

- Poor thread engagement.
- 25° thread angle does not match the M10 nut thread angle.
- Abundant free space (black).
- Minimal mass available to take load, threads are vulnerable to bending and stripping under load.

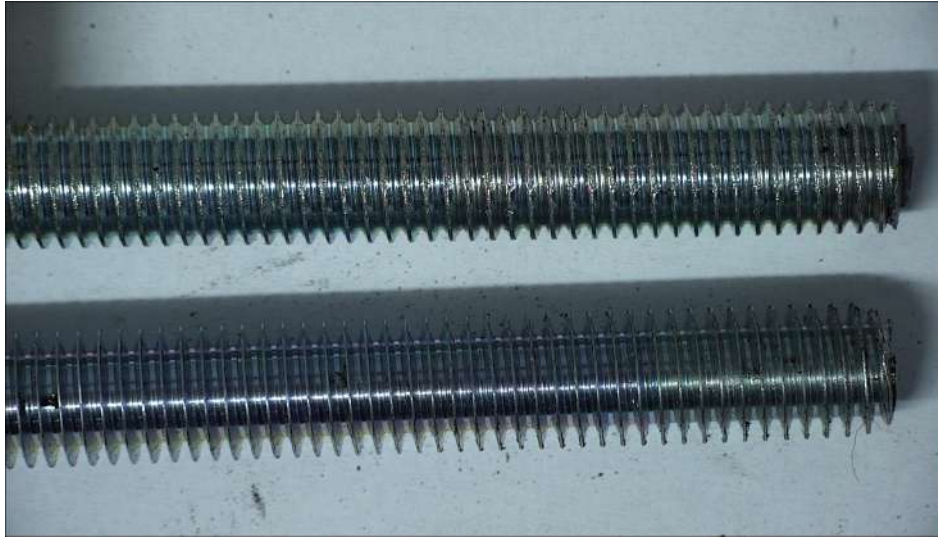
Each sample was examined visually and using low-power magnification and clear differences were observed, figures 1 to 3.

Figure 1. The samples as presented. Sample “Local” above, “Import” below.

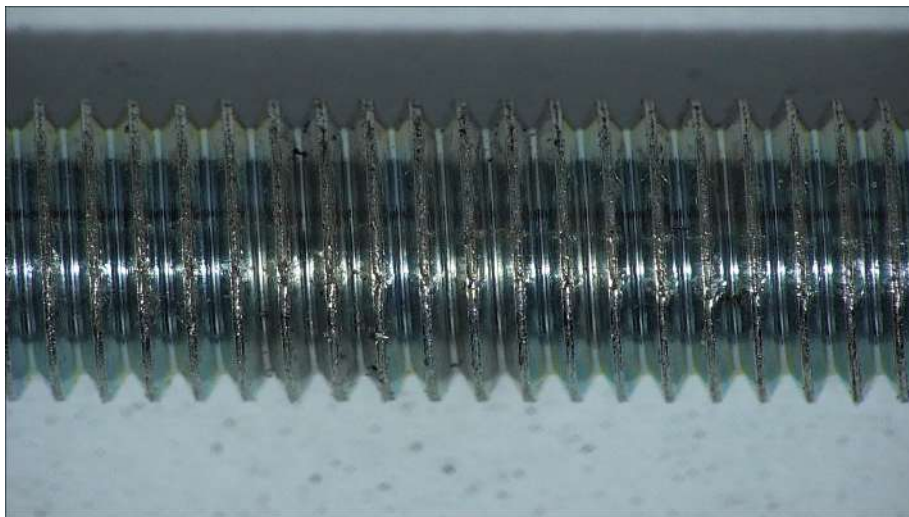
Figure 2. Close-up image of “Local” sample.
